AN OPERATIONAL RESEARCH INVESTIGATION OF THE  
ICE-DETECTION CAPABILITY AND UTILITY OF THE  
SURFACE CONDITION ANALYZER (SCAN) SYSTEM  
AND ITS APPLICABILITY TO NAVY-WIDE USE

Calspan Report No. 6283-M-1

MARCH 1979  
CONTRACT NO. N00014-78-C-0284  
FINAL REPORT

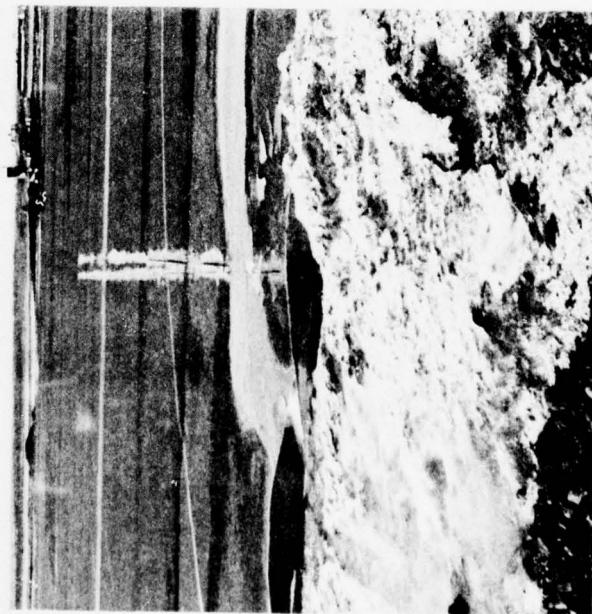
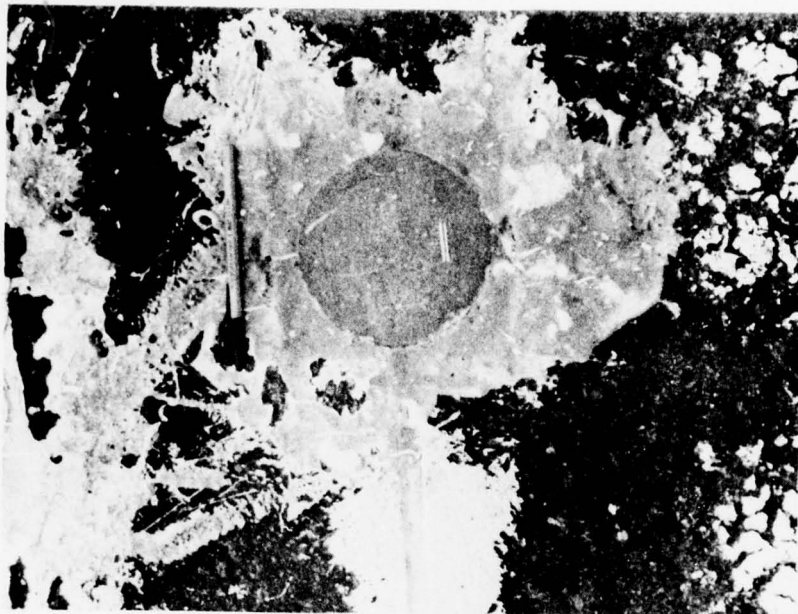
Figure 8 PHOTOGRAPH OF NAS KEFLAVIK SENSOR INSTALLATION

a) VIEW SHOWING EPOXIED CUT IN RUNWAY

b) TOP VIEW OF SENSOR IMBEDDED IN RUNWAY

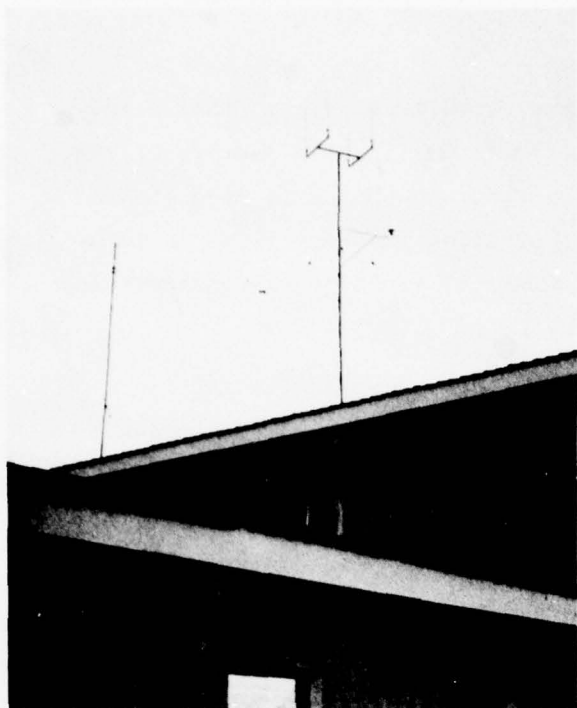
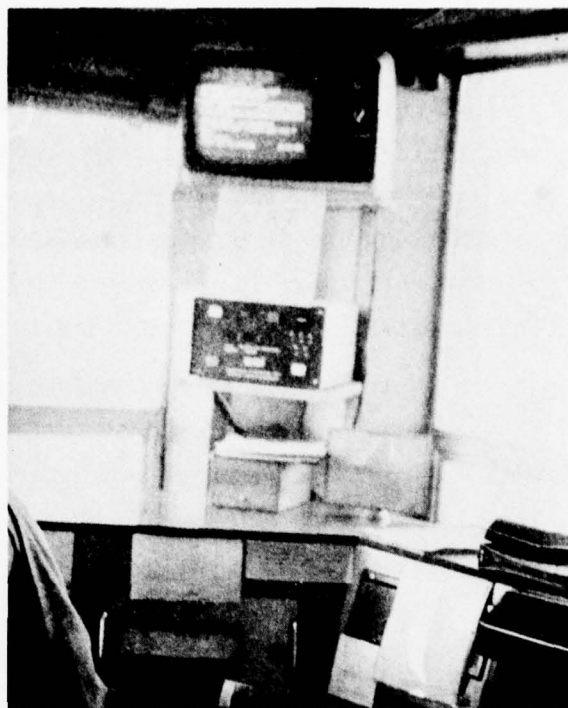
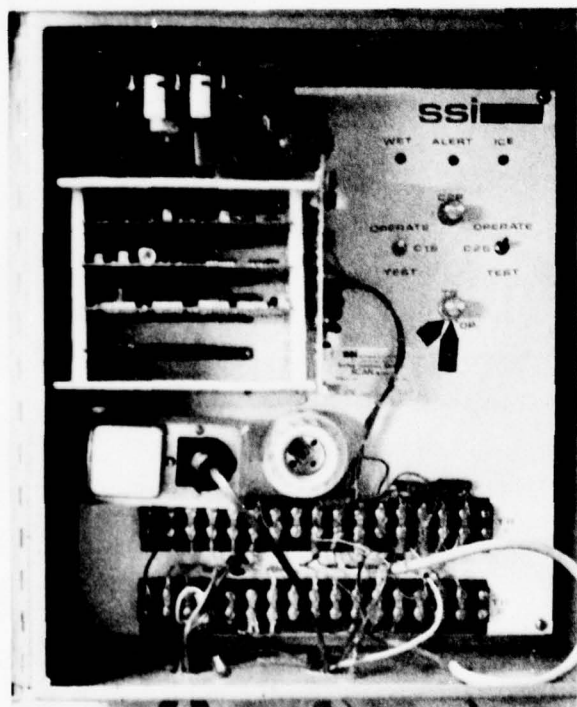
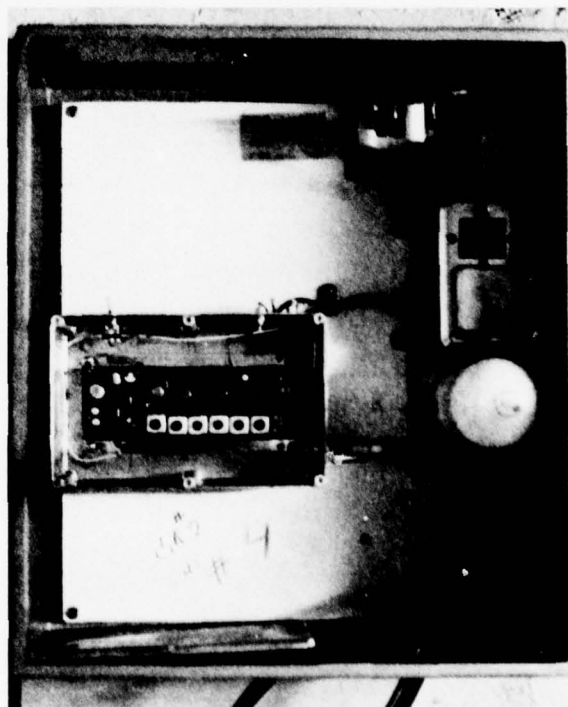
Figure 14 VIEWS OF SCAN SYSTEM COMPONENTS INSTALLED AT KEFLAVIK

Figure 14 provides photographs of other components of the SCAN system installed at USNASKEF. Figures 14c and d show, respectively, views of the remote processing unit (RPU) and transmitter electronics for sensor #4, located in an underground bunker housing the arresting gear mechanism. Figure 14a shows the radio telemetry receiving antenna and air temperature sensor on the roof of the Fire House. Figure 14b shows the display terminal (approximately centered in the photograph) located in a prominent position in the Fire Department's Communications Center.

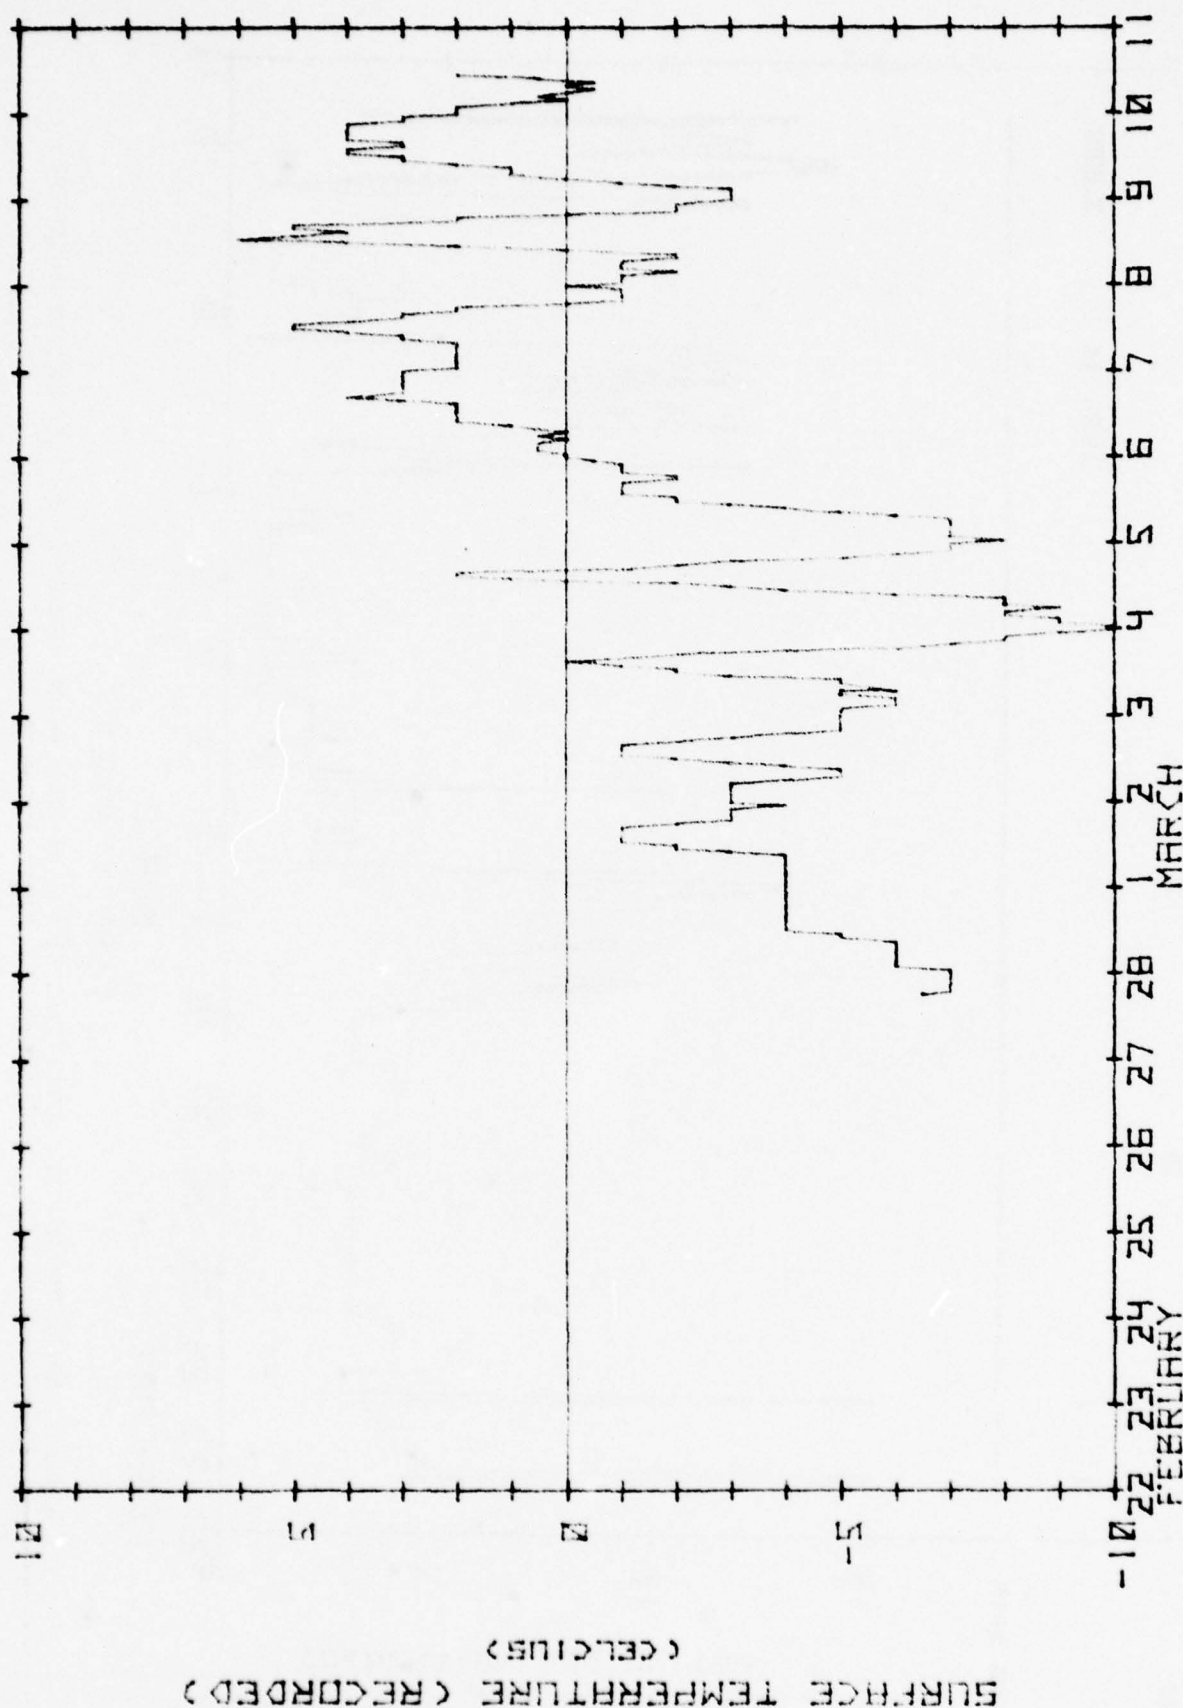
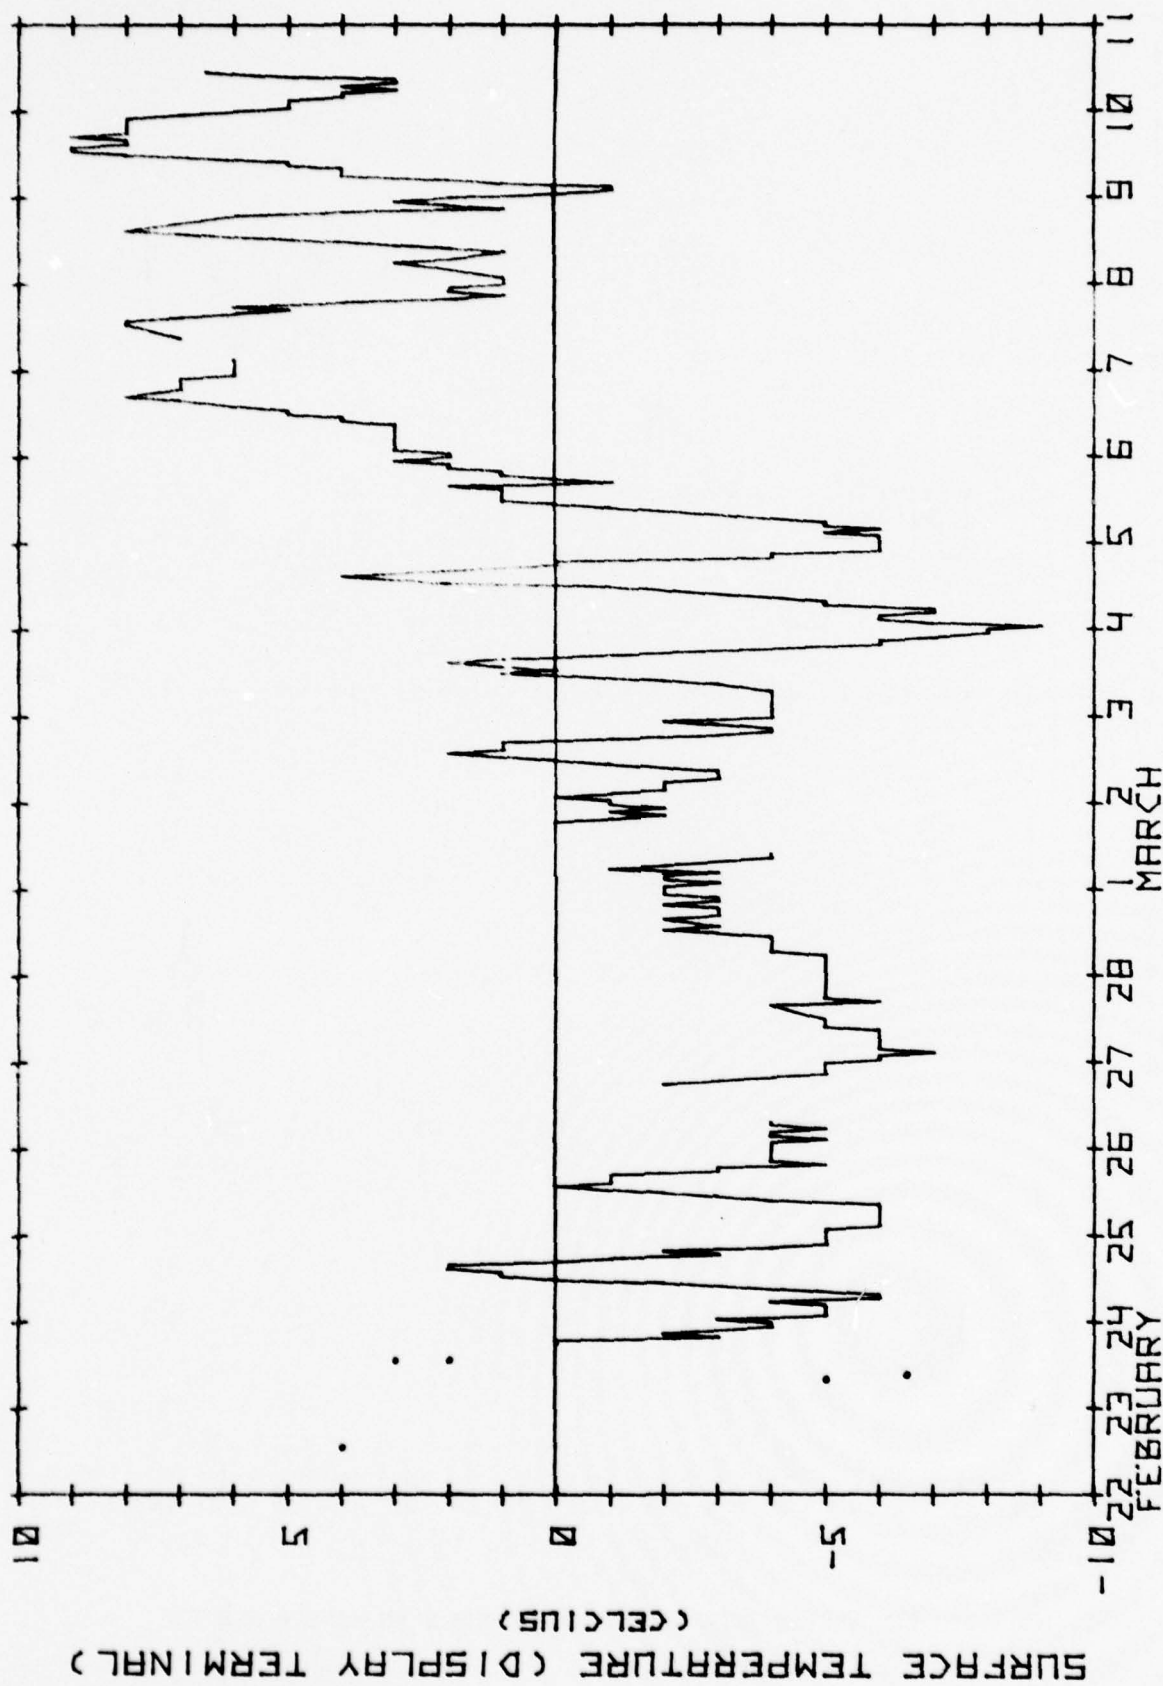
An apparent drift in the electronics between the RPU and display terminal, for the one sensor monitored at Keflavik, caused displayed temperature to read  $4^{\circ}\text{C}$  warmer than actual sensed surface temperature -- a potentially serious, but correctable, error for effective and timely implementation of anti-icing strategy.

Figure 17: RECORD OF SURFACE TEMPERATURE RECORDED AT THE REMOTE PROCESSING UNIT OF SCAN #4

Figure 18: RECORD OF SURFACE TEMPERATURE RECORDED FROM THE DISPLAY TERMINAL FOR SCAN #4

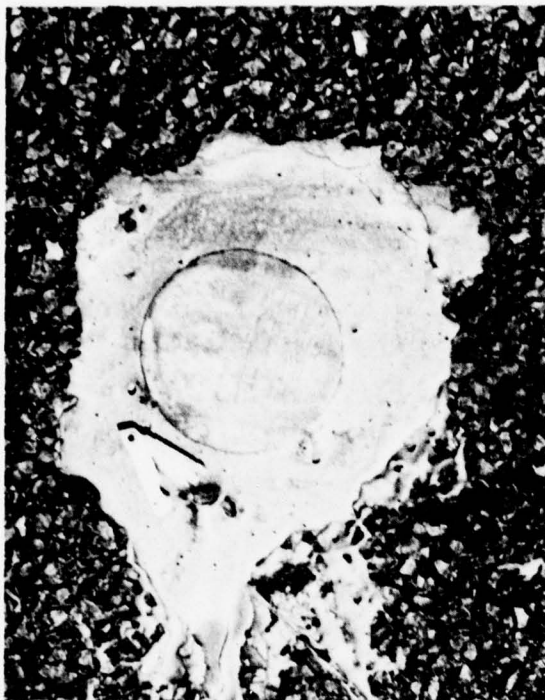
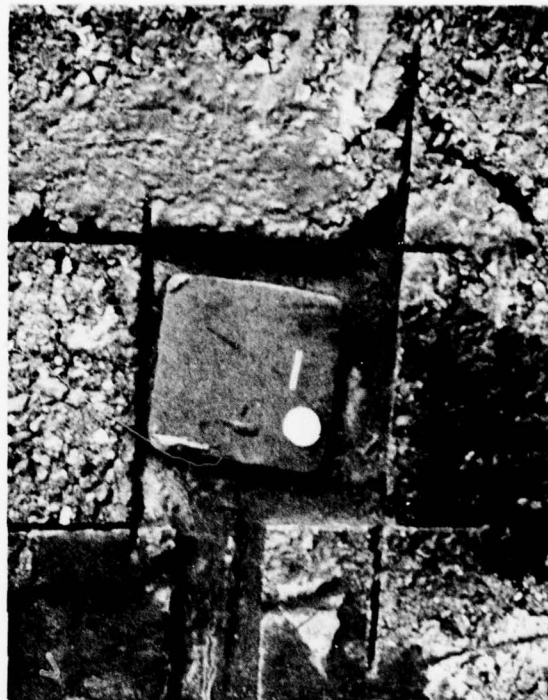
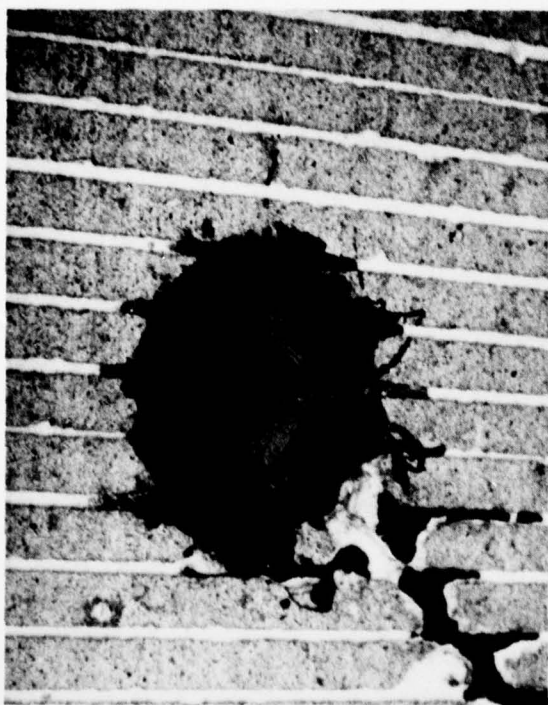
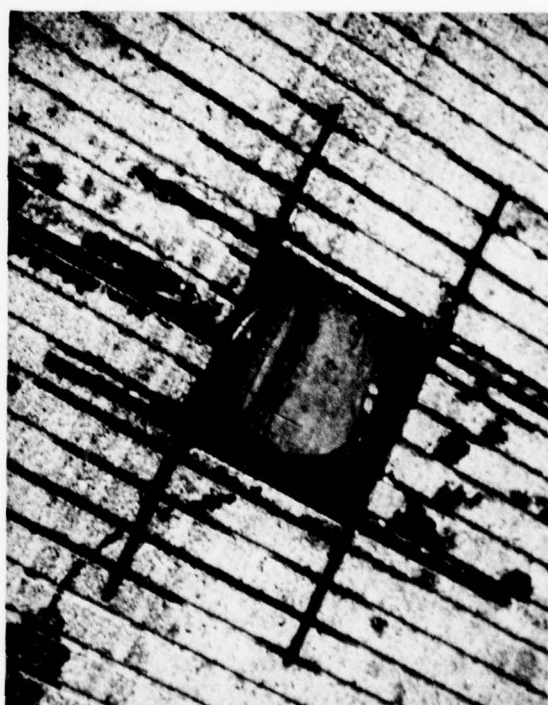
Figure 20 VIEWS OF SCAN SENSOR INSTALLATIONS AT FOUR AIRFIELDS

Sensor installation appears haphazard, probably as a result of improper installation procedures by airport maintenance personnel, and sensors do not always match the color and roughness characteristics of the runway surface. Figures 20a-d provide views of typical sensor placements at Scott AFB, Anchorage, Cincinnati, and Detroit, respectively. Note, for example, the extremely rough runway surface surrounding the sensor in Figure 20a, the major depression (allowing accumulation of water and ice/snow) around the square (obsolete version) sensor in Figure 20b, the overly darkened (tar covered) sensor in Figure 20b, and the partially tar-covered sensor in Figure 20c. These types of mismatch of sensor and runway surface characteristics are no doubt responsible for much of the observed discrepancy in "surface condition" between the runway and sensor surfaces.

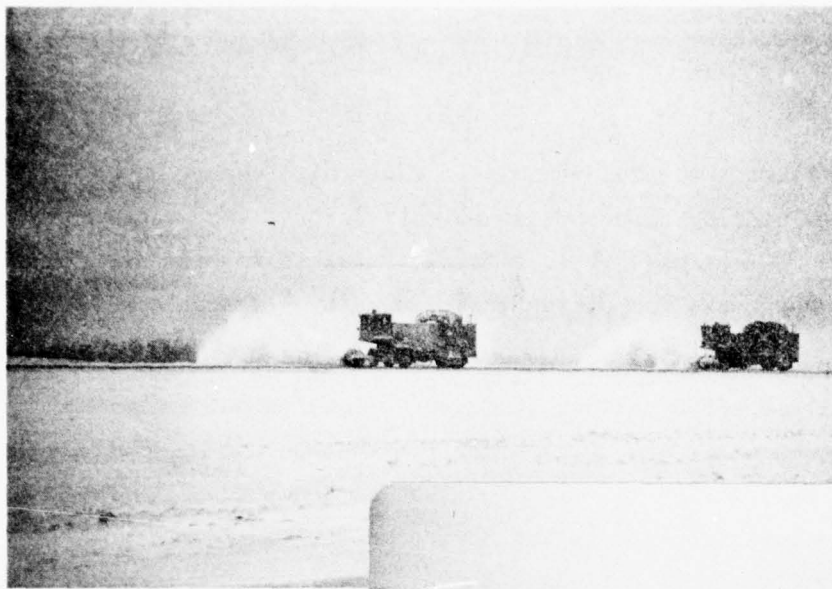
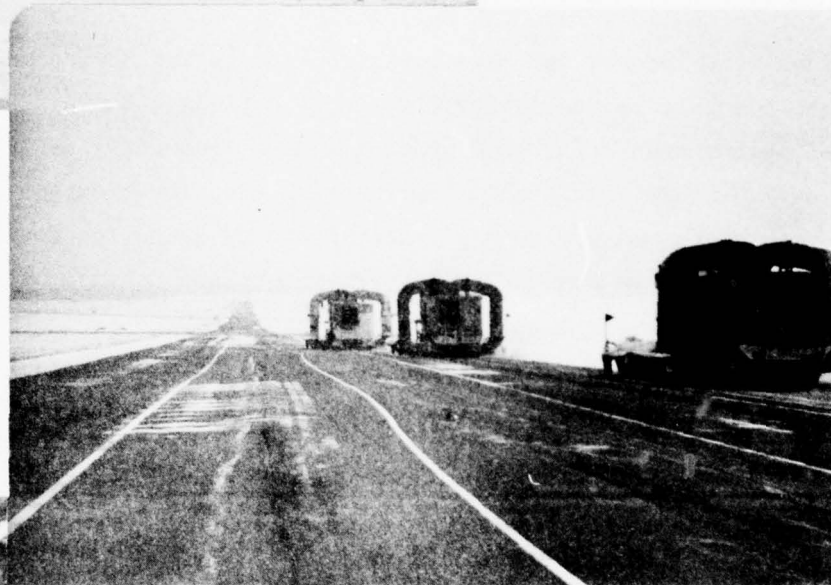
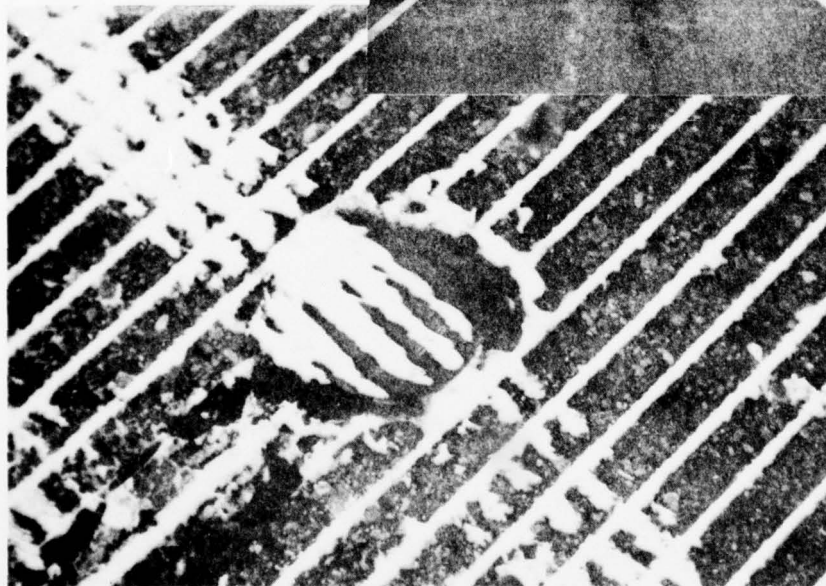
Figure 21 VIEWS OF A SNOW REMOVAL OPERATION AND SCAN SENSOR WITH TIRE TRACK AT CINCINNATI
